# North Fork Siuslaw Sediment & Habitat Assessment

Final Draft - 2008

Prepared by Demeter Design

Prepared for the Siuslaw Watershed Council

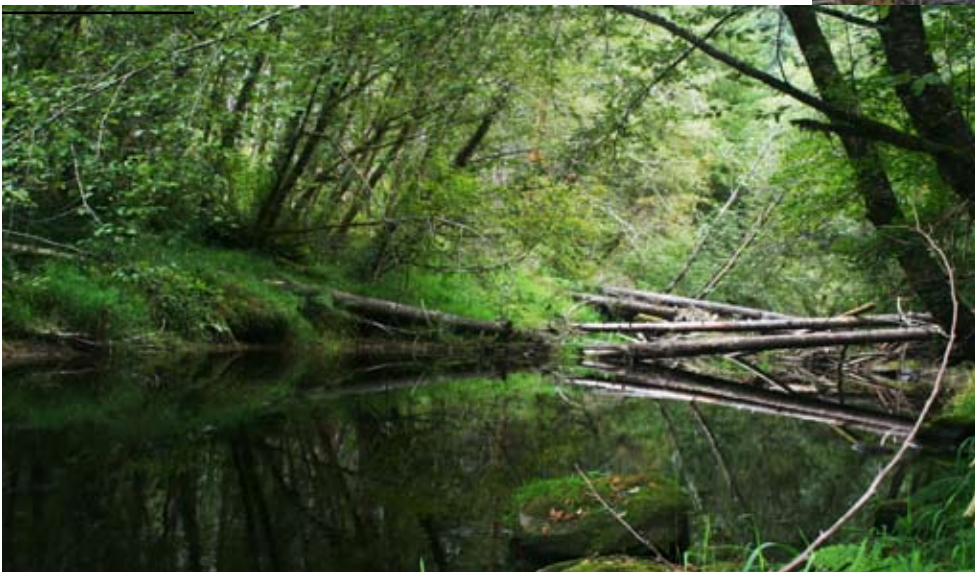
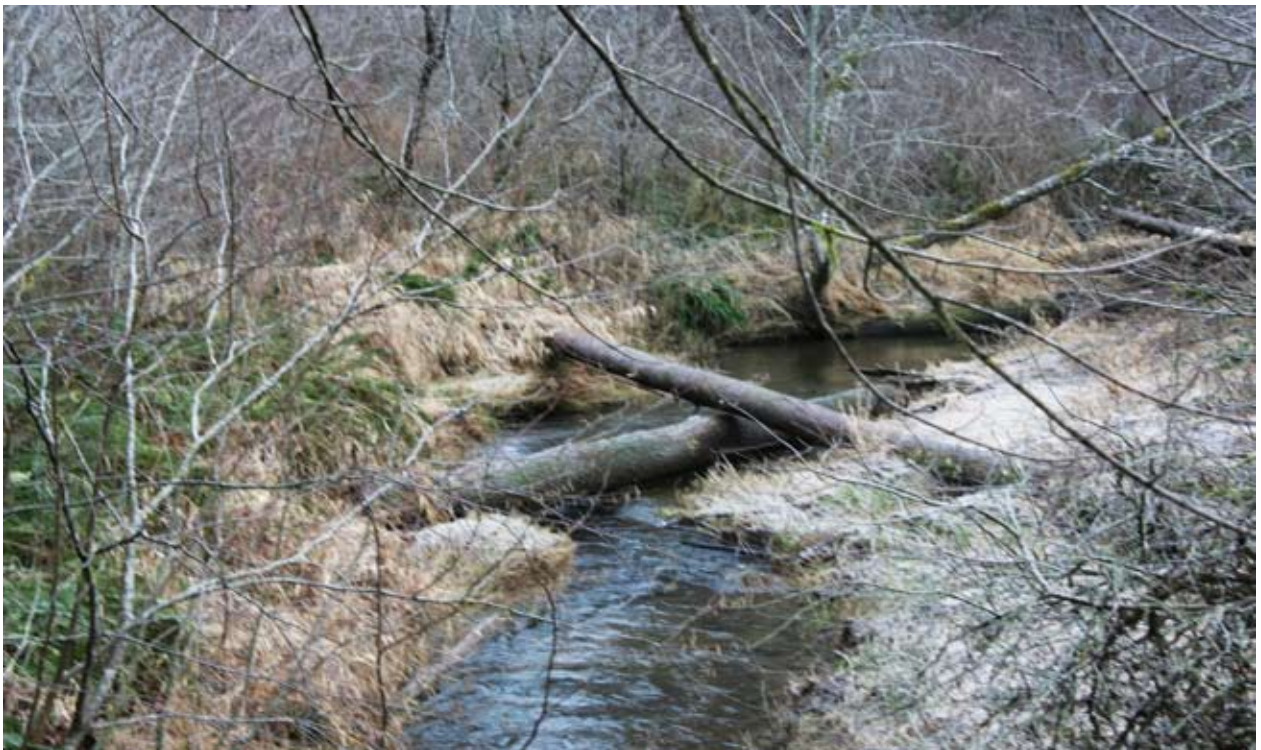
Prior to 1969, excess logging debris was discarded into streams resulting in a stream network choked with wood which blocked fish passage and decreased dissolved oxygen. In the 1970s, an effort was initiated by various agencies to remove debris from the stream network. Although this effort was intended to improve fish habitat, too much debris was removed. The result was stream channel simplification and the loss of critical instream habitat complexity. Subsequent research clearly indicated the importance of LWD in developing and maintaining healthy aquatic habitat conditions<sup>1</sup>. To correct the situation, the USFS and partners initiated an aggressive effort to replace LWD throughout the stream network. These restoration efforts are still underway. In 2006 the USFS identified a need to plan restoration projects specifically within the NFS.<sup>2</sup> The SWC is an active partner in log placement and riparian planting projects throughout the basin. A map of completed restoration projects can be found on page 52, Map 8. The photographs below are two examples of wood placement in the NFS basin.

The following four pictures were taken in the NFS basin on USFS land and are examples of some of the restoration activity in the watershed. While many of the log structures observed were providing key habitat components such as refuge from predators and potential overwintering shelter during high flow events, it appears that no log placements occurred in headwater channels. The high average gradient in headwater channels prevents effective sediment storage without the presence of large wood and/or boulders. The lack of large wood due to the Umpqua fire, extensive timber harvests, and management induced debris flows has likely disrupted the natural sediment storage capacity of these headwaters.<sup>1</sup> See the map of known restoration projects on page 52, Map 8.

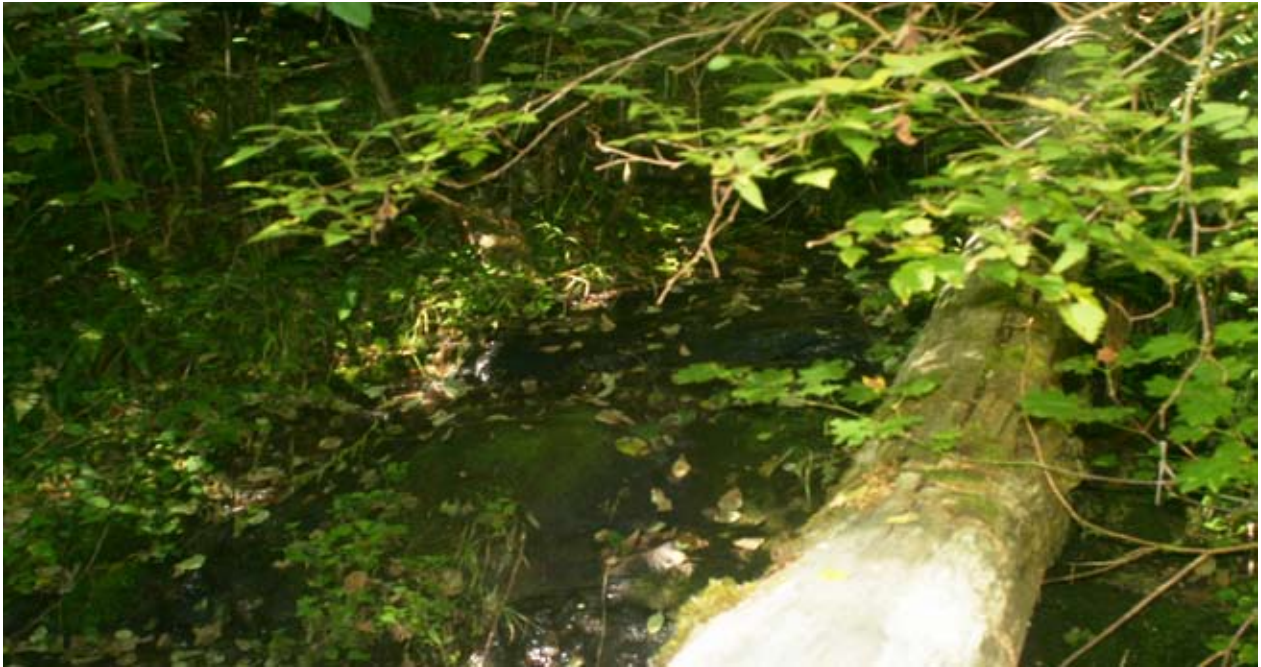
This is an example of a 1A\_2. At this point, there is no sign of active erosion or human presence but the stability is driven by the bedrock outcropping. This photograph was taken in the NFS.

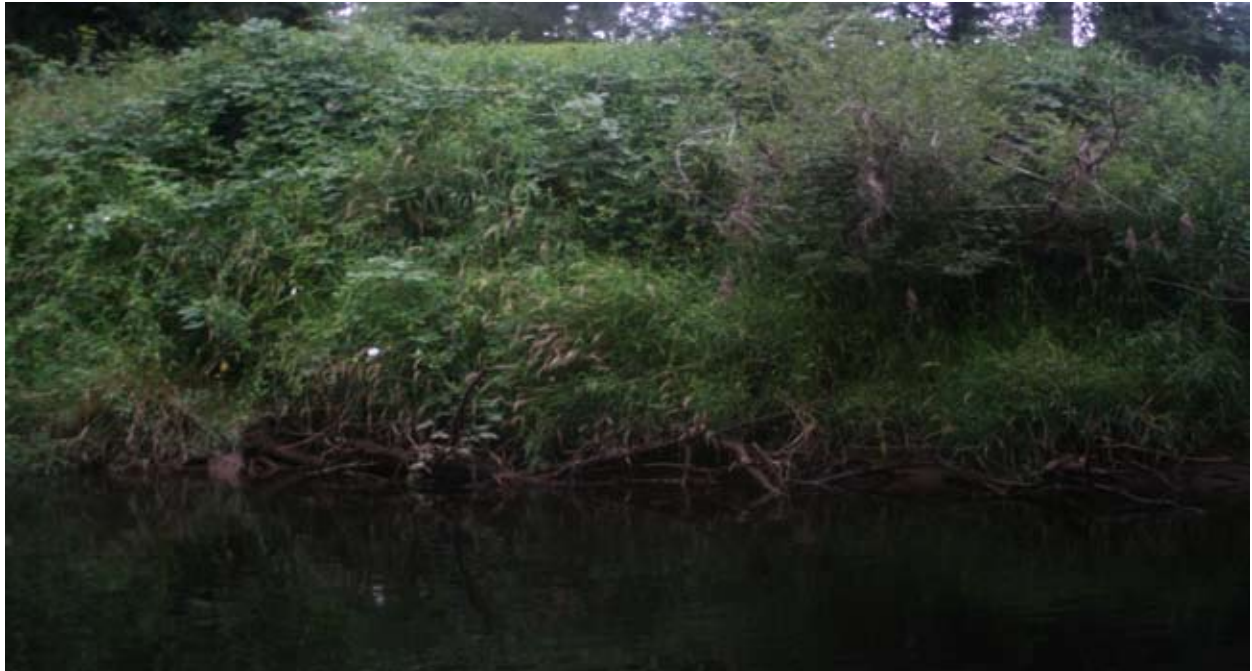
This is an example of a 1B. At this point, there is no sign of active erosion but strong human presence, Himalayan Blackberries and Reed Canary Grass on the bank of a private residence. This photograph was taken in the NFS.

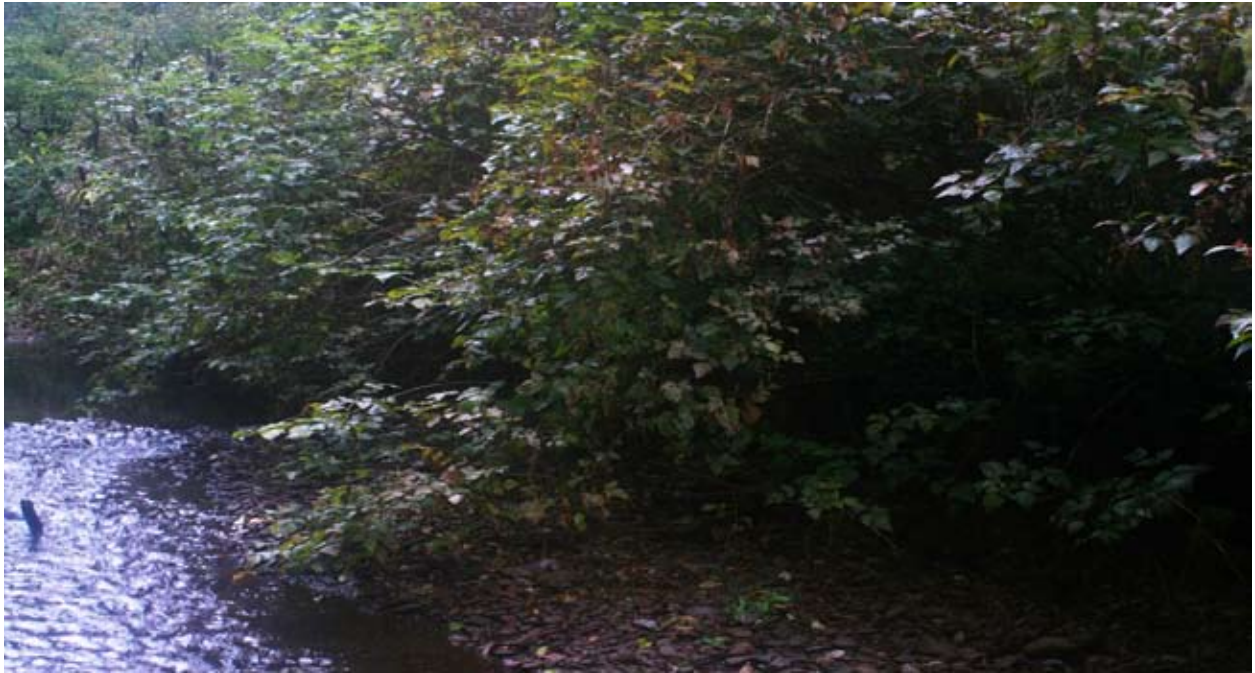
This is an example of a 2A. At this point, there is little sign of active erosion and no human presence. While not visible in this photograph, the erosion is occurring behind the overhanging vegetation. This photograph was taken in the NFS.

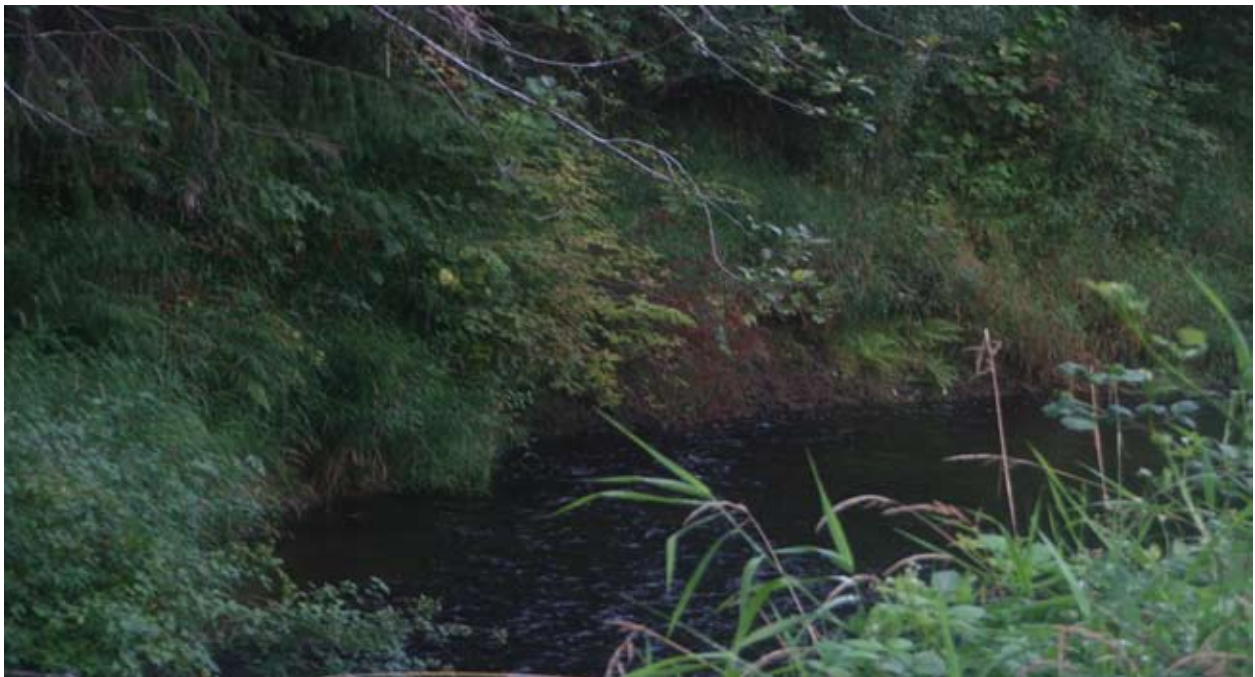
This is an example of a 2B. At this point, there is little sign of active erosion with human presence with Reed Canary Grass on the bank of an unused pasture. This photograph was taken in the NFS.

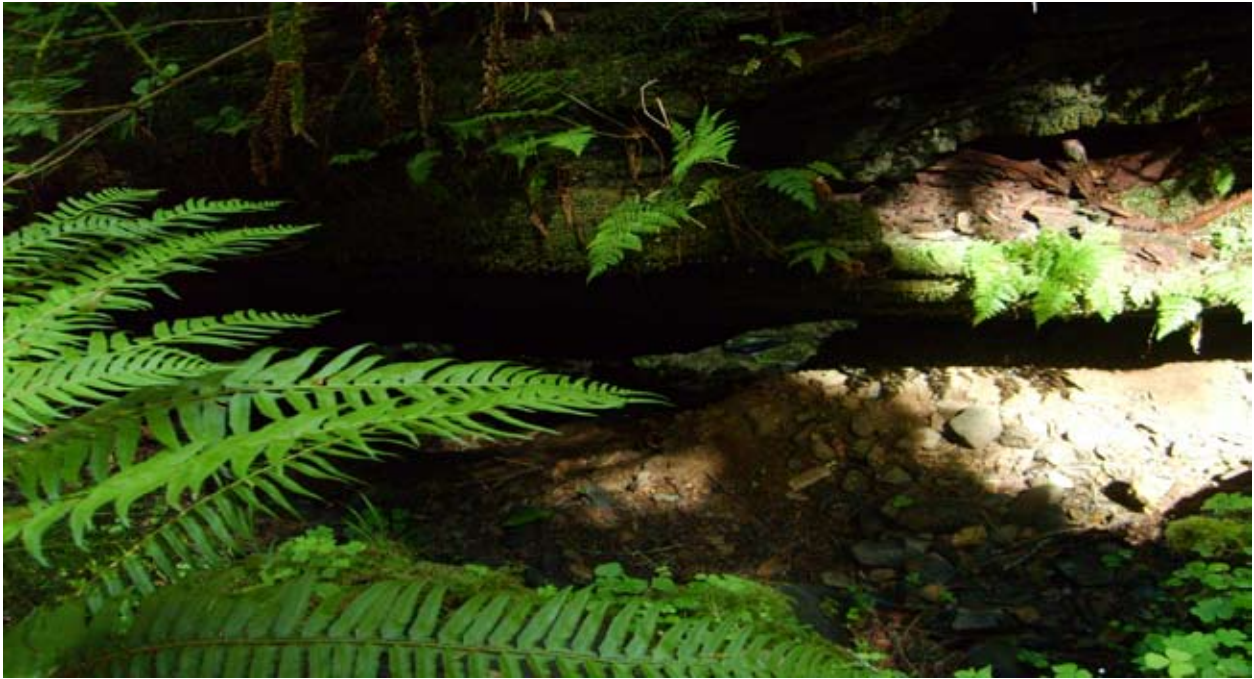
This is an example of a 3A. At this point, there is clear evidence of active erosion and no human presence. This photograph was taken in the Wilson River Basin in Tillamook Oregon.

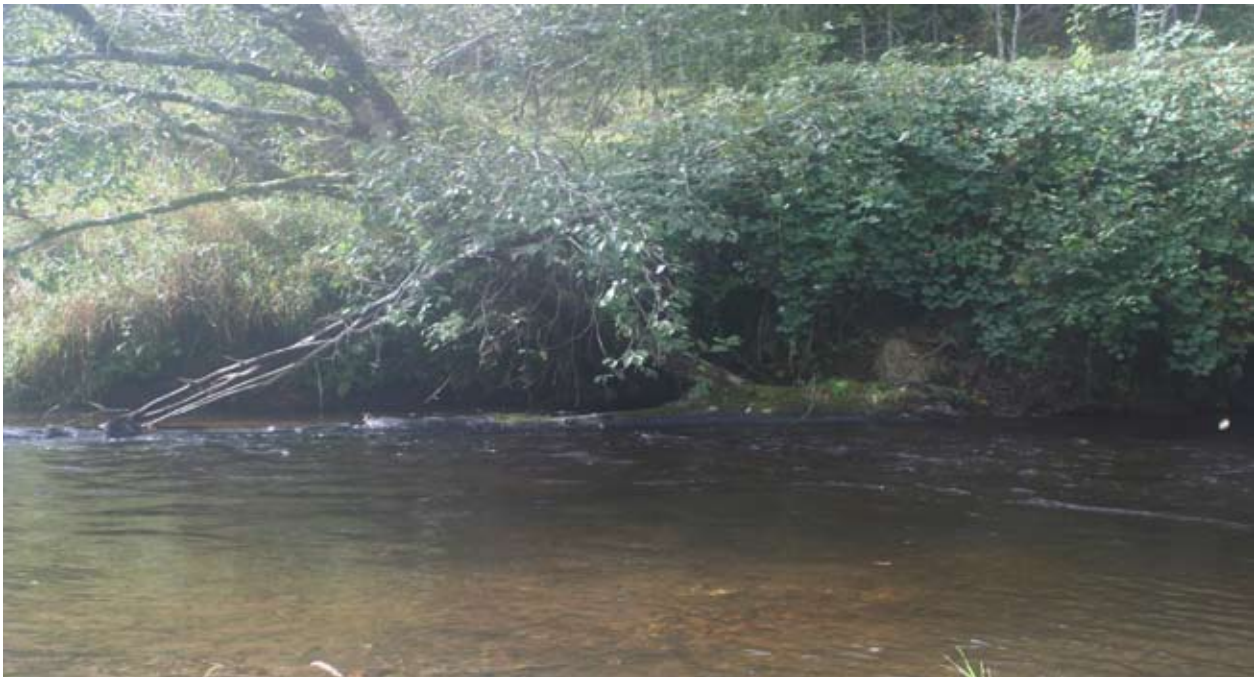
This is an example of a 3B. At this point, there is clear evidence of active erosion with human presence. While not visible in this photograph, the erosion is occurring behind the overhanging Himalayan Blackberry. This photograph was taken in the NFS.

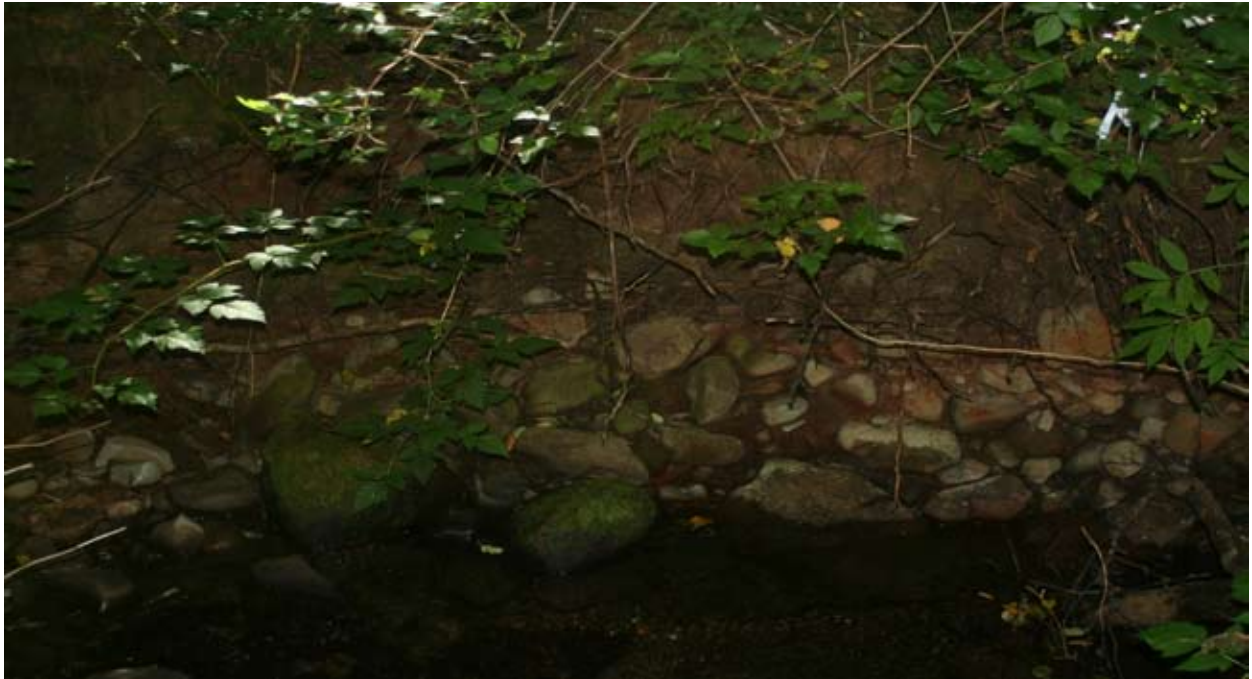
This is an example of a 4A. At this point, active erosion is nearly taking place on the entire bank. There is little vegetation and the presence of Salmon Berry which correlates strongly with disturbance. There is no human presence. This photograph was taken in the NFS.

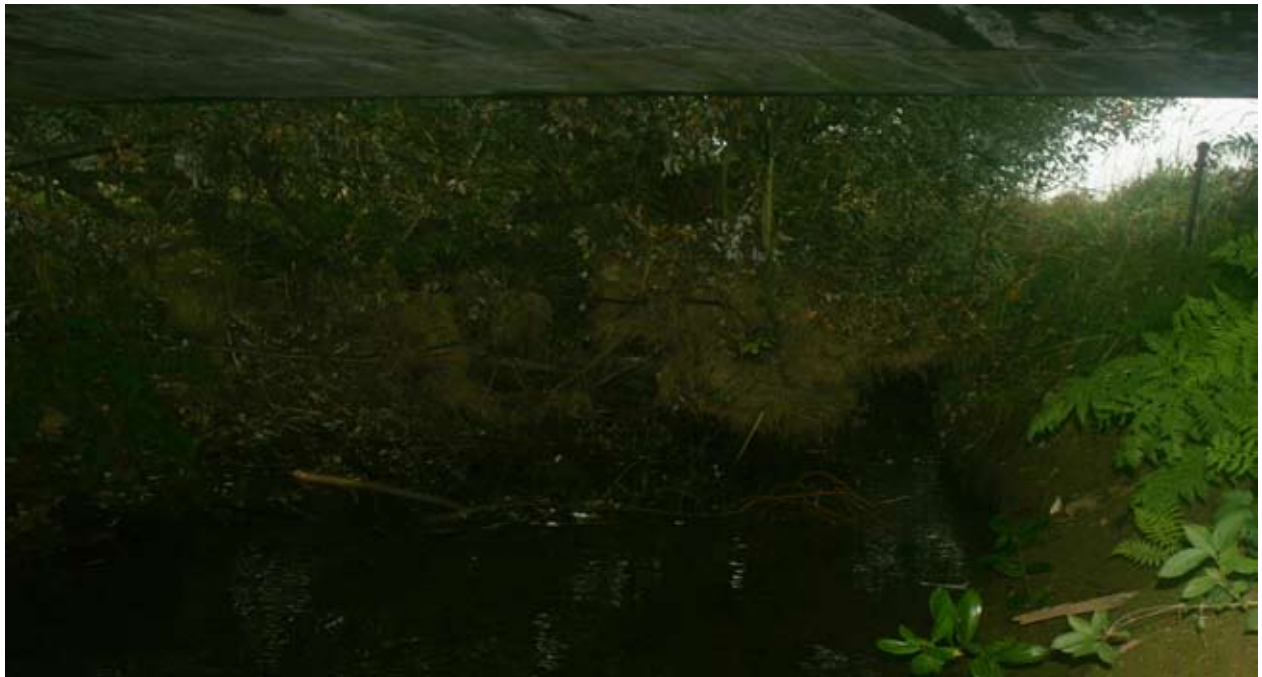
This is an example of a 4B. At this point, active erosion is nearly 100% of the bank with human presence. This photograph was taken next to a bridge in the Tillamook River basin in Tillamook Oregon.

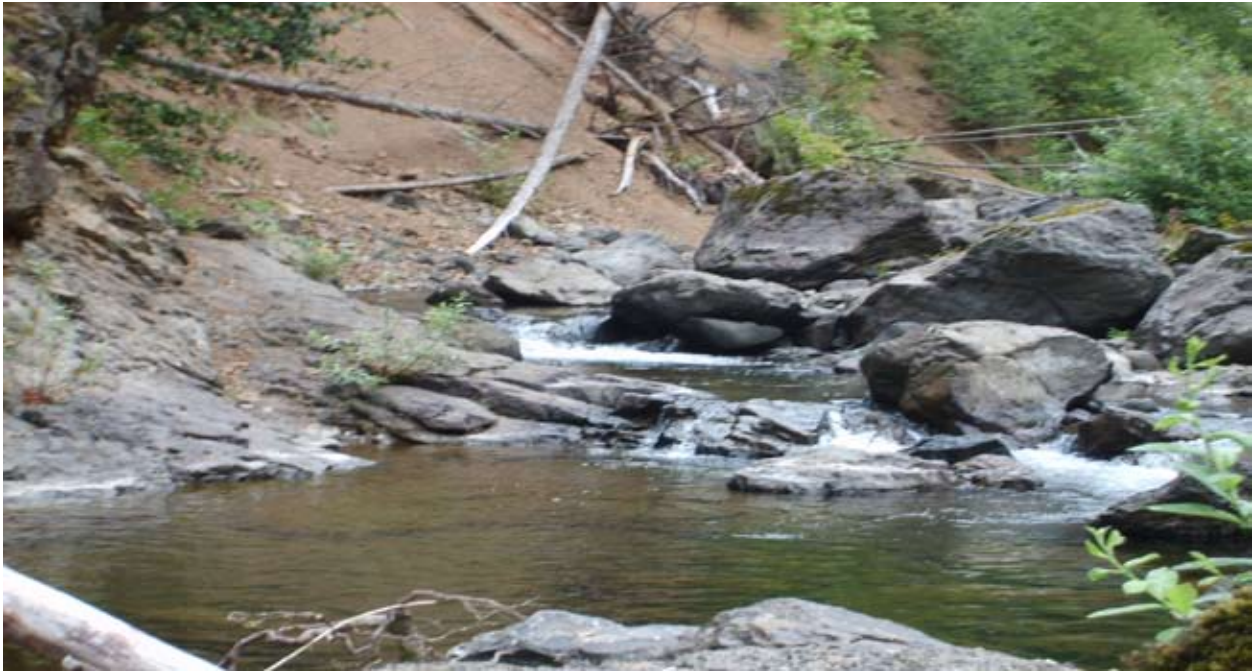
This is an example of a 5A. At this point, there active erosion is complete with minimal human presence. It is important to note that 5A sites are much less common than 5B sites. This channel was a confined bedrock chute along HWY 6. The road is greater than 30 vertical meters from the channel but less than 30 horizontal meters away. This landslide is not directly caused by the presence of a road. This photograph was taken in the Wilson River Basin in Tillamook, Oregon.

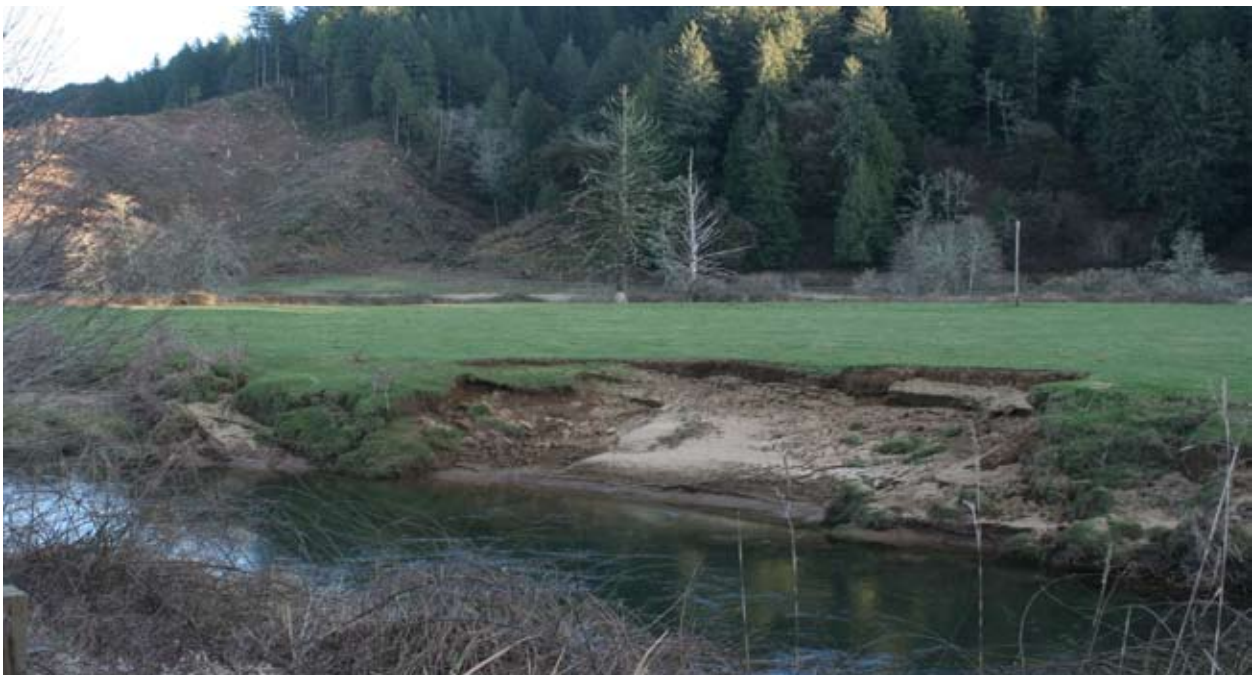
This is an example of a 5B. At this point, active erosion is complete with human presence. This pasture was being actively grazed at the time this photograph was taken. There was no clear cattle exclusion. This photograph was taken in the NFS.
