# Tillamook River Coho Restoration Strategy; Habitat Assessment and Limiting Factors Analysis

Demeter Design ~ December 31, 2008

Data Analysis and Reporting Conducted by Demeter Design Inc.  
Habitat Data Prepared by Demeter Design Inc.  
Habitat Data Collected by Demeter Design Inc. and Bio-Surveys LLC.  
Production Modeling Prepared by Bio-Surveys LLC.  
Landslide Potential Analysis Conducted by Oregon Department of Forestry

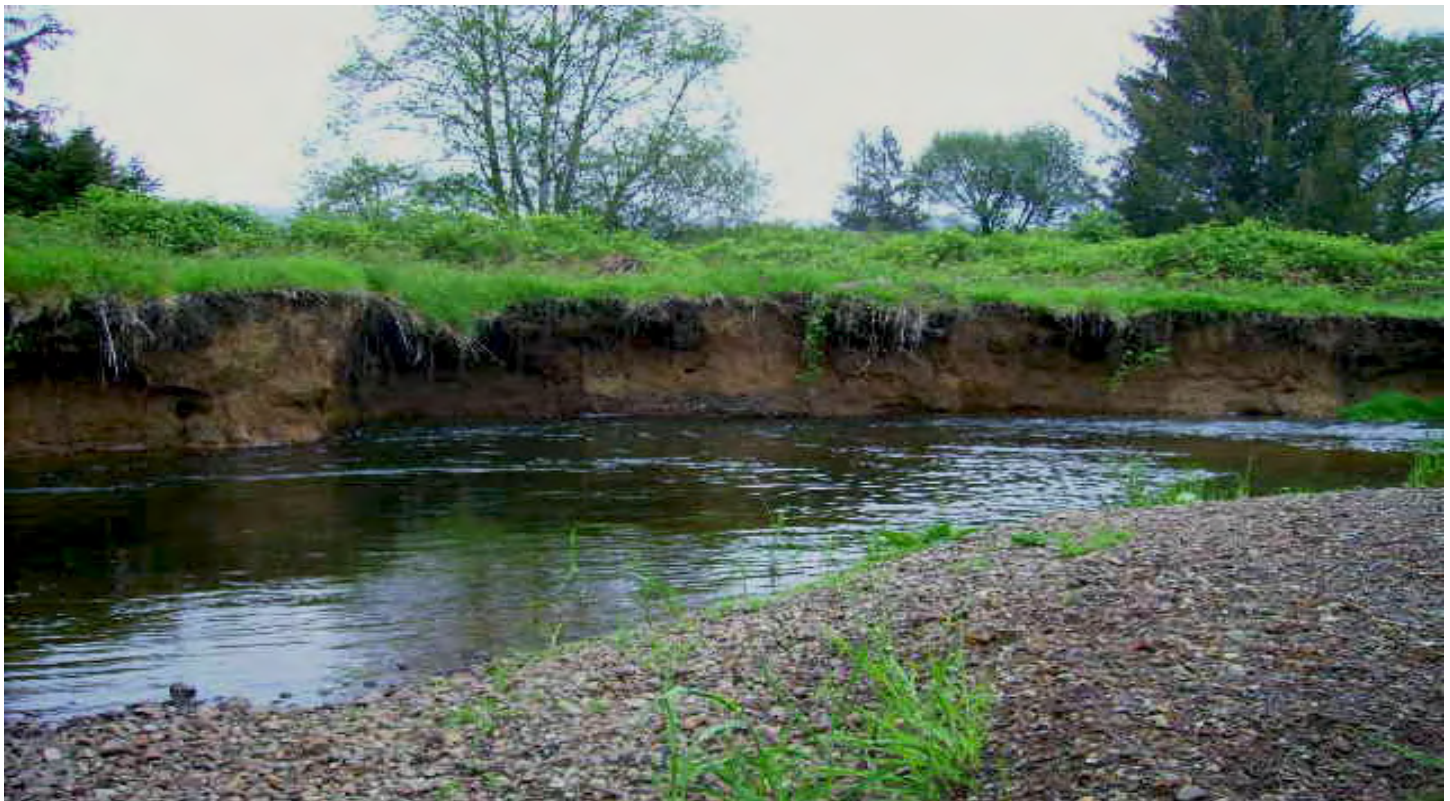
Table 3.02e - AQI Pool Volume

A low functioning anchor (1) occurs on the middle mainstem. This potential anchor has abundant gravels, no wood, minimal pools and is severely impacted by land-use. Although this reach provides 2/3 of the spawning gravels within the entire Tillamook River Watershed, Bio-Surveys disagreed with the classification of this section as an anchor.

A second low functioning anchor site (2) occurs between the confluence of Simmons Creek upstream to Fawcett Creek (~reach 5-8). Well sorted gravels are rare likely due to lack of LWD, but the potential for floodplain connection exists and gravels are present. Currently the channel is entrenched, and has poor to moderate riparian conditions (% Shade is well below benchmarks). The long term potential for restoration is very high in this section for multiple species including Chum, Steelhead, Chinook, and Lamprey. Although the % Pools is just above the low benchmark it is likely that given the low gradient and broad floodplain of the mainstem, historical pool volume would be much greater than the high benchmark. Current function is mixed with spawning habitat function high to moderate in reach 6 through half of reach 7 and low in reach 8. Summer rearing is low above reach 7 although the mixing action of the rapid in reach 7 could potentially mitigate some of the impacts of excess temperatures thus increasing summer rearing potential in reach 6 and the lower part of reach 7. Wood placement would increase rearing habitat through floodplain connectivity and would also sort gravels being delivered from Munson and Simmons creek. Existing pools would benefit from wood placement as well due to increased cover from predation, complexity, and hydraulic roughness. Summer juvenile rearing densities were lower in this anchor than in non-anchor sites in 2006 and 2007. One hypothesis for this is that surveyors observed juveniles migrating to cooler waters in 2005 while in 06/07 surveyors did not observe this migration due to timing. In other words, although all RBA surveys occurred before summer peak temperatures, the 2005 surveys may have occurred at the onset of increased summer temperatures.

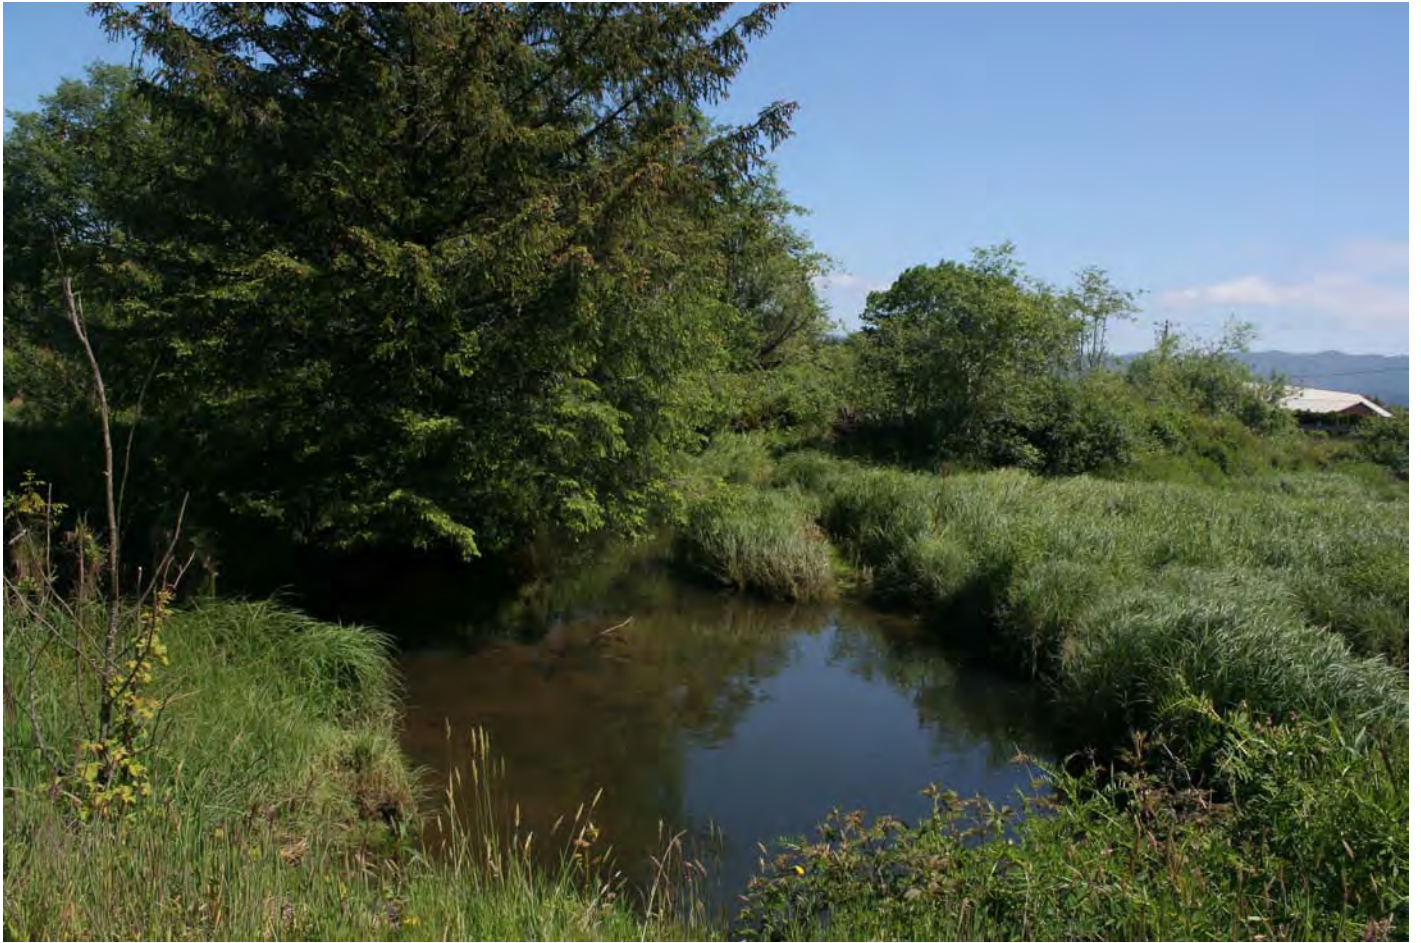
Map 3q - Esther and Tomlinson Creek

- The tidegate at the mouth of Esther & Tomlinson closes prematurely and functions as an adult and juvenile barrier under certain tidal conditions. When accessible, the habitat upstream is extremely productive for winter rearing. Replacement or modification of this barrier will increase winter habitat for Tillamook & Trask River juveniles.

- A culvert perched 2' on Tomlinson Creek just above tidal influence is a juvenile (all species) and adult Chum barrier and blocks access to cold water summer habitat. Replacement of this barrier will primarily increase summer habitat for all species.

- The second culvert on Tomlinson Creek is undersized and failing. Significant spawning resources are located upstream. Replacement of this potential barrier will maintain long term function.
